10/18/2016

Discharge Volume Calculation Report

CMC Land Holdings, LLC

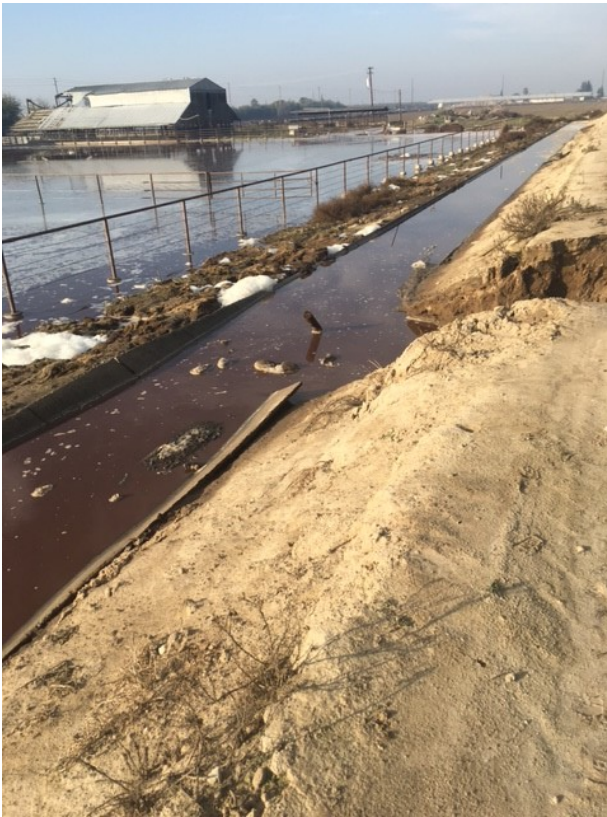
Figure 1. Water surface in TID canal at Location of breach. 11/20/15 – 8:12am

- 3.1 Survey of TID Canal. Based upon the survey results, it becomes apparent that the TID concrete canal south of the south storage pond embankment acted as a dam during the discharge. As the embankment eroded during the discharge event, the water from the storage pond flowed out of the pond to the south and intersected the TID concrete canal. The concrete canal essentially became a dam to prevent further erosion and further discharge, figure 1. As shown in figure 6, only water at elevations higher than the top of TID canal could escape over the top of the TID canal and into the corrals. This is evidenced in figures 1-3, that show that the water surface in the storage pond, in the breach and in the canal were all at the same elevation at the time the breach was stopped with repairs to the embankment. The elevation of this water surface is the same as the canal south bank shown in figure 2, which was surveyed on 10/4/16. Therefore, water in the storage pond at elevations lower than the top of the TID canal was not released because the TID canal acted as a dam. See survey plan in appendix B and figure 6 for orientation of pond and canal.

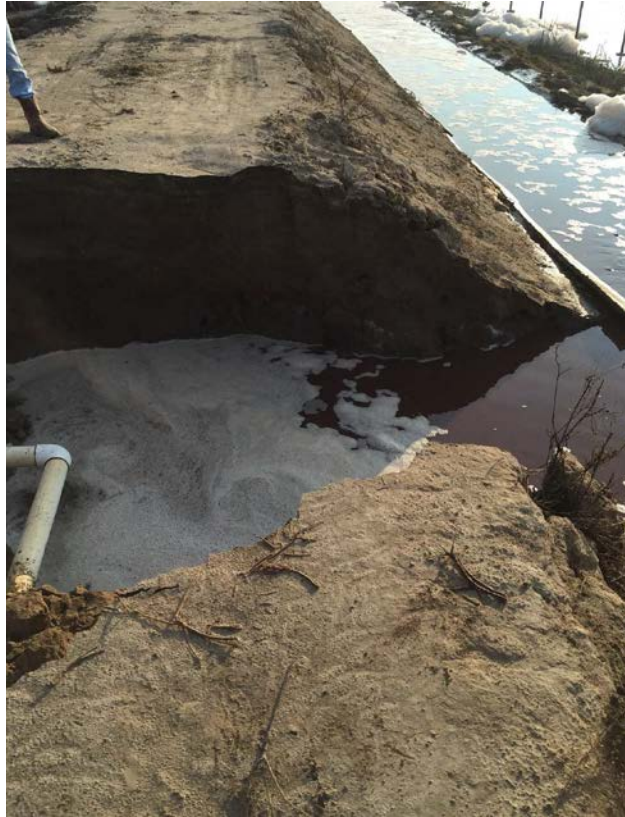
Figure 2. Water surface in breach 11/20/15 – 8:12am

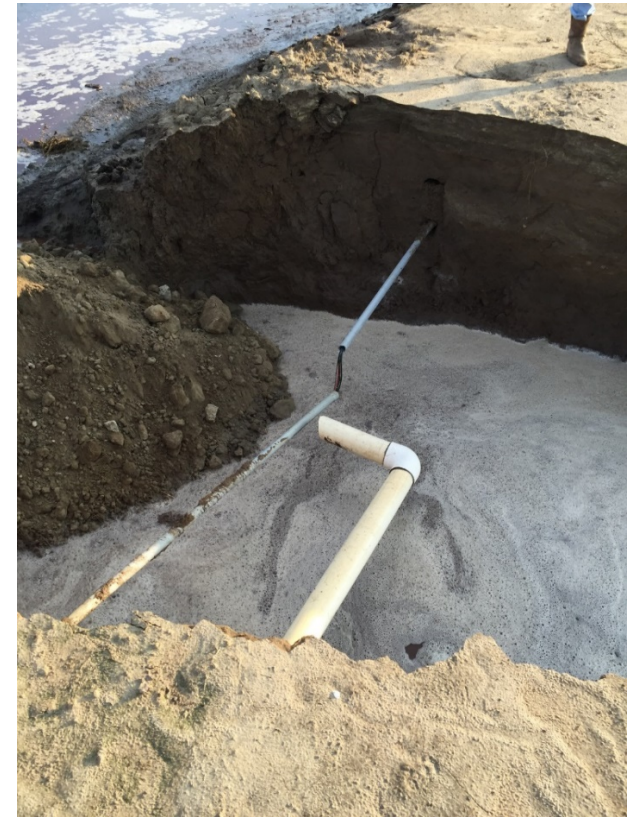
Figure 3. Water surface in breach and storage pond. 11/20/15 – 8:11am

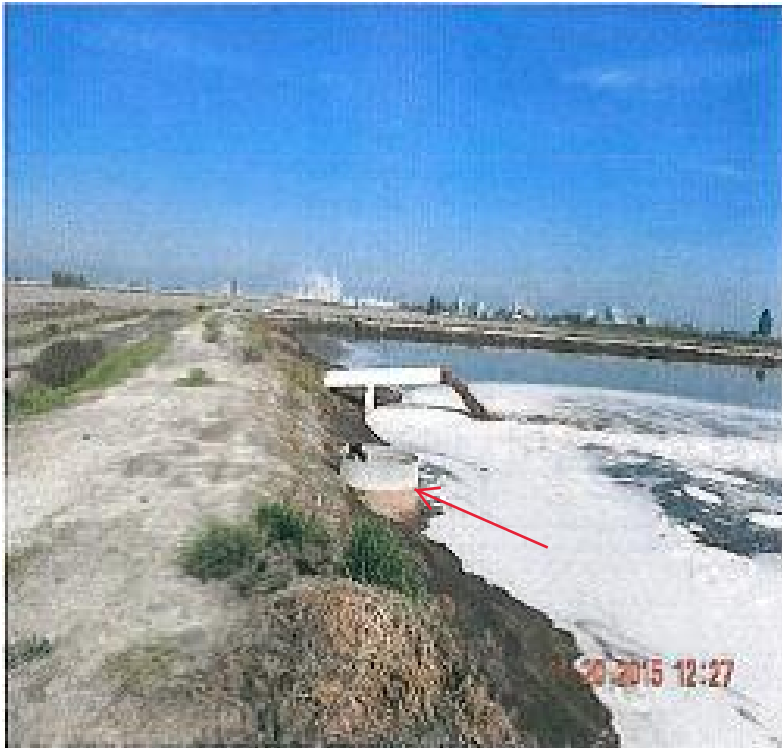
3.2 Survey of Highwater Marks. The photos taken at the site on 11/20/15 identify high water marks on various PVC and concrete structures within the settling basin and storage ponds, figure 4. As shown in figure 4, the concrete and PVC vertical pipes are still wet from the pond level prior to the discharge. These high water marks are still evident at the site, figure 5, and were surveyed on 10/4/16 to identify an elevation of the high water level in the storage pond and settling basin. The high water marks are both accumulated organic material affixed to the structure and red staining of the structures from wastewater. Several structures with high water marks were identified and surveyed in both the settling basin and storage pond. These high water marks indicate the water level, and amount of available freeboard, in the

settling basin and storage pond immediately prior to the discharge. Using the average elevation of the top of the embankment and the average elevation of the high water marks, the settling basin had 1.89 feet of freeboard(north embankment) and the storage pond had 2.04 feet of freeboard immediately prior to the discharge(south embankment), table 1. The amount of freeboard in both ponds were noted to be roughly the same. This is likely because a channel had been excavated between May and July 2015 in the interior embankment between the settling basin and storage pond due to a plugged weir box. This allowed the water surface in the settling basin and the storage pond to be equal, as the two ponds were directly connected, which was shown by the high water mark elevations.

Figure 4 – High Water Mark on pond structures – photo from RWQCB Inspection Report – 11/20/15 – 12:27pm

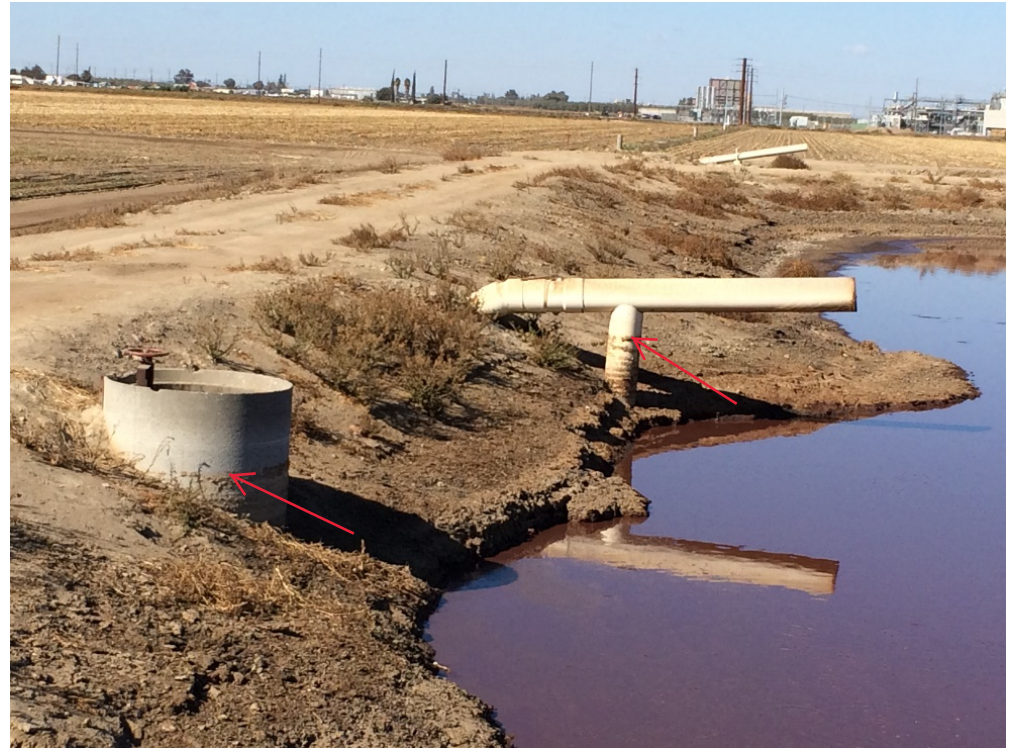
Figure 5 – High Water Mark on pond structures – Photo taken 10/4/16
